NASA
Technical Paper 1835

Effects of Geometric Variables on Rub Characteristics of Ti-6Al-4V

Technical Paper 1835

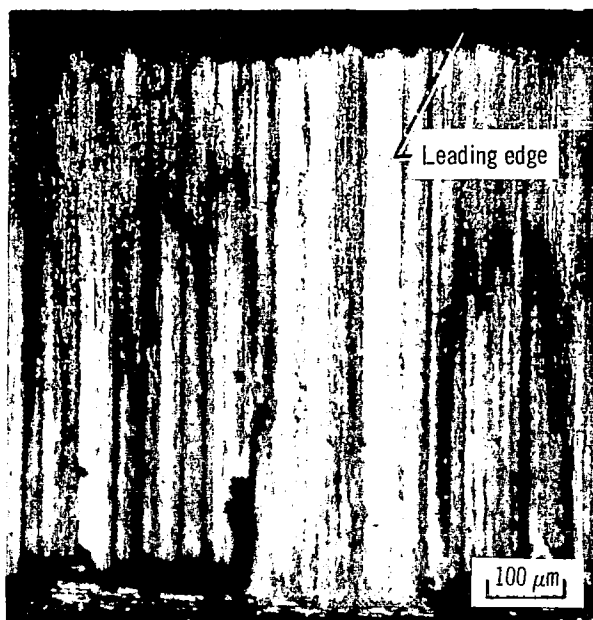
Figure 8. - Thin (0.8-mm-thick) Ti-6Al-4V blade tip after rub interaction against 21-percent-dense Hastelloy-X fibermetal. Blade tip velocity, 114 m/sec; incursion rate, 25×10^{-6} m/sec; 10-blade interaction.

The condition of the thin blade tips after a rub interaction is represented by the photomicrograph in figure 8. Five to 10 micrometers of smeared, transferred seal material is present over nearly the entire blade tip. In addition to transfer, wear of the thin blade tip was in evidence. Blade tip wear was concentrated in scratches, about 10 to 20 micrometers deep, crossing the entire blade tip

thickness over about 25 percent of the tip width. In addition, 30 to 40 micrometers of wear was evident at the blade tip leading edges. Altogether, the total volume of material removed from the thin blade tips was estimated to be 20 to 30 percent less than the volume of material removed from the 3.2-micrometer-thick blade tips.

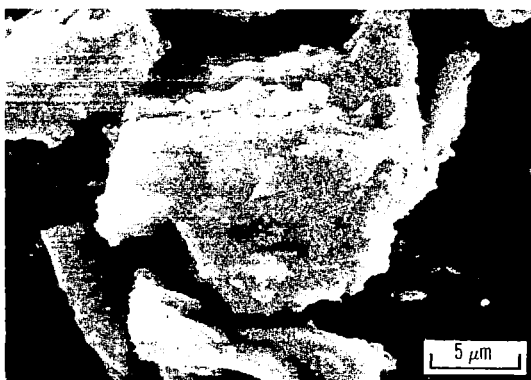
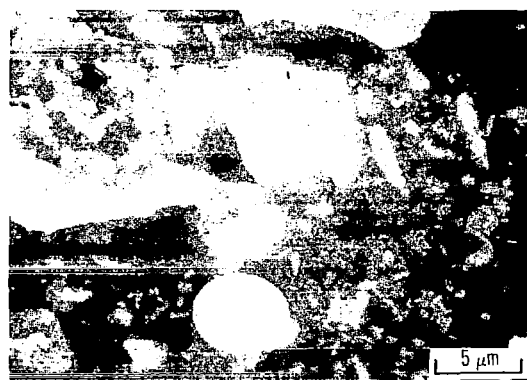
(a) Typical debris particles.

(b) Layered debris.

(c) Spherical debris.

(d) Energy dispersive X-ray analysis of (c).

Figure 9. - Wear debris from rub interaction between thin (0.8-mm-thick) Ti-6Al-4V blade tips and 21-percent-dense Hastelloy-X fiber metal. Blade tip velocity, 114 m/sec; incursion rate, 25×10^{-6} m/sec; 10-blade interaction.
